COUNTY LOUTH GOLF CLUB COURSE IRRIGATION

NOTES OF VISIT 8TH AUGUST 2017

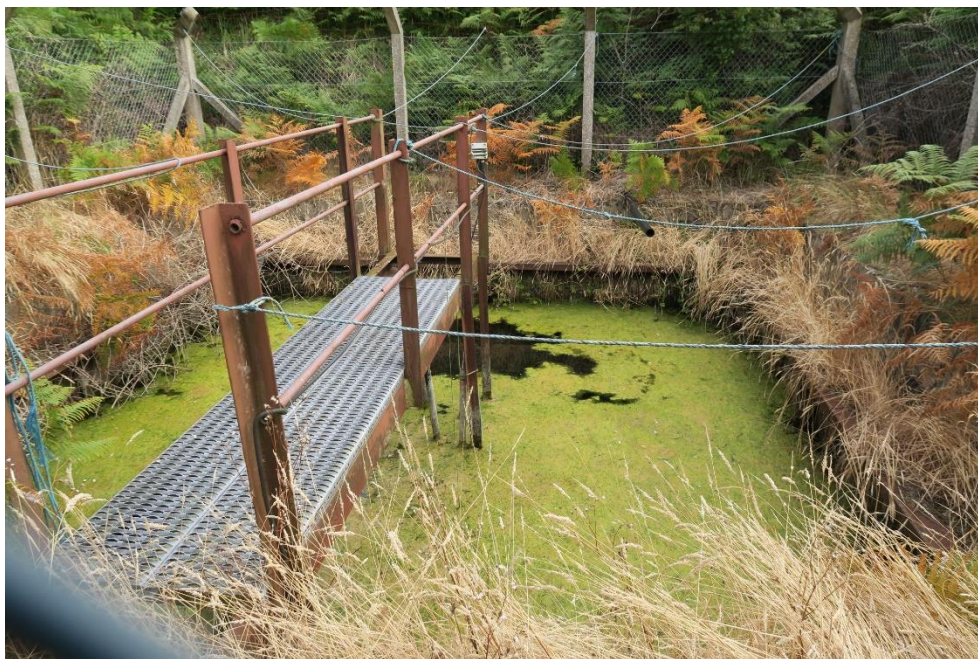
1 – Water supply @ 4th Hole – Note; water quality

- 2.8** The water quality in the open hole for the 4th Fairway supply had large volumes of algae (see photo) which is not good for water quality and the irrigation system.

- *Monitor the pH and alkalinity levels and correct these as necessary.*
 - *Ensure no algae at the water supply source locations.*
- 2.10** **Water Storage**

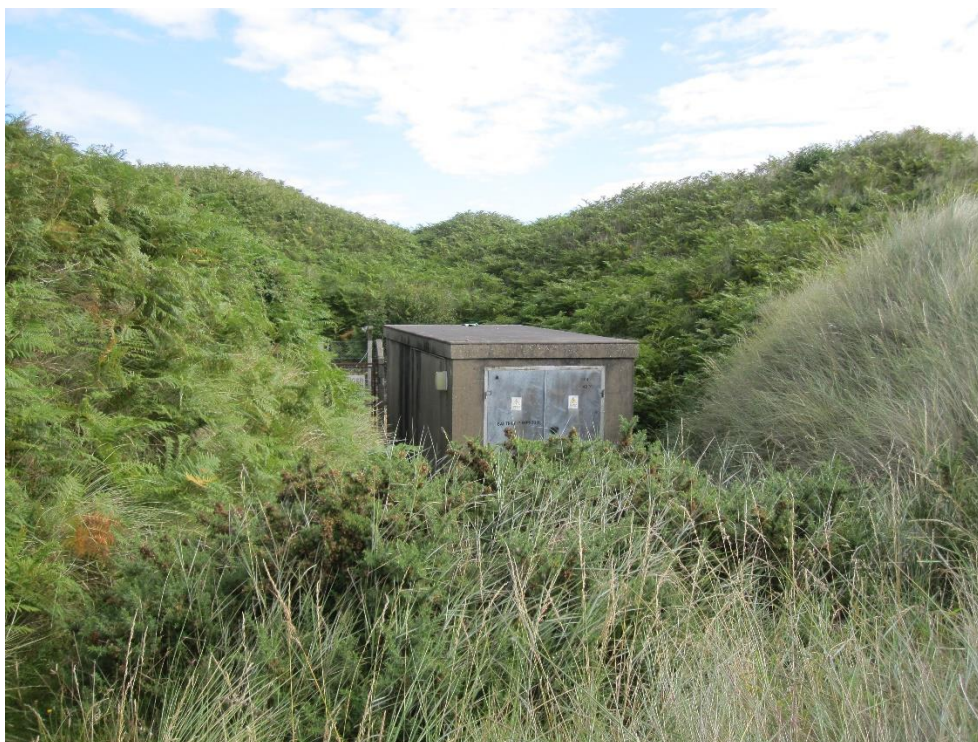
2 – Pump house - @ 4th Hole

2.23 The irrigation pump station and controls are in their own dedicated concrete block building beside the 4th Fairway ‘open hole’ at the spring location. Whilst the block work appears relatively sound it is likely to be in the wrong location for any future upgrading

- *There is likely to be a need for a new pump house beside a new water storage tank. A fully lined GRP pump house would be suitable – see appendix photos – or similar block built construction as the existing pump house.*
- *Ensure the pressure vessel is checked (short term).*
- *Ensure the pump station is serviced so it can get through the 2018 season [it will need replacing in the future so limited funds should be spent] (short term).*
- *Replace the existing pump station using modern technologies.*
- *Confirm the available power supplies at any future location.*
- *Any future pump house and pump station works should be undertaken with full consideration of the future design requirements of the irrigation system to the golf course.*

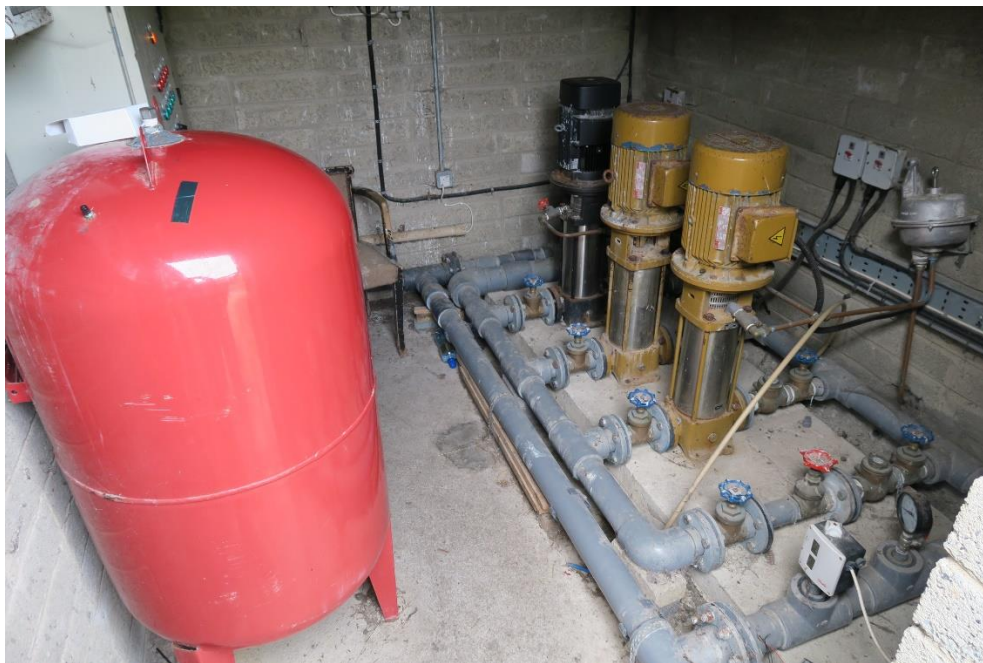
3 – Irrigation pump station within pump house – Note uPVC and manual prime etc

2.24 The pump station uses three Grundfos CR pumps which are of varying ages and operated from a pressure switch to provide a pressurised irrigation system. The pump station, however, was not operating correctly during the visit and it was reported there have been problems over the 2017 season. There is a pressure vessel and with modern H&S there is a need to ensure this is regularly [at least annually] checked for integrity to confirm it is in suitable working order. It was not known when the pressure vessel was last checked and therefore it needs to be checked urgently.

2.25 The pump station design is 25+ years old with what appears to be a single newer Grundfos pump and two older Grundfos pumps. Despite the newer pump the control and configuration is antiquated and not harmonised and we would recommend a new fully automatic pump station to operate the golf course irrigation. The location of this will need to be determined in any future irrigation designs.

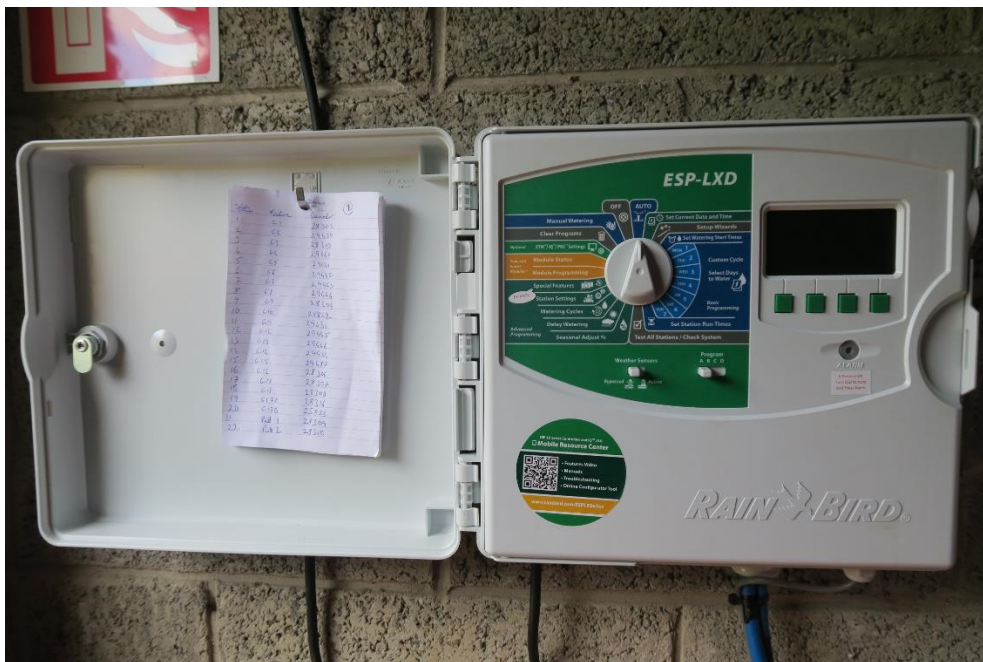
4 – Irrigation controller in pump house

- 2.36** **Control System & Control Cable**
- 2.37** The control system infrastructure is generally 30+ years old, however, the decoders and controller have been upgraded. The controller, which is only a small element of the overall system, was replaced in 2017. It is a Rainbird ESP-LXD wall mounted, electronic, decoder controller. Whilst this is suitable for operation of the irrigation system as currently designed we would recommend a computerised irrigation controller in the future as these provide more flexibility for finite control of water and where water is applied.

- 2.40** *Recommendations;*
- *Replace the control system including, controller (a computerised controller should be installed), control cables and decoders / communication modules when undertaking upgrading works to the hydraulic element [main line] of the irrigation system.*

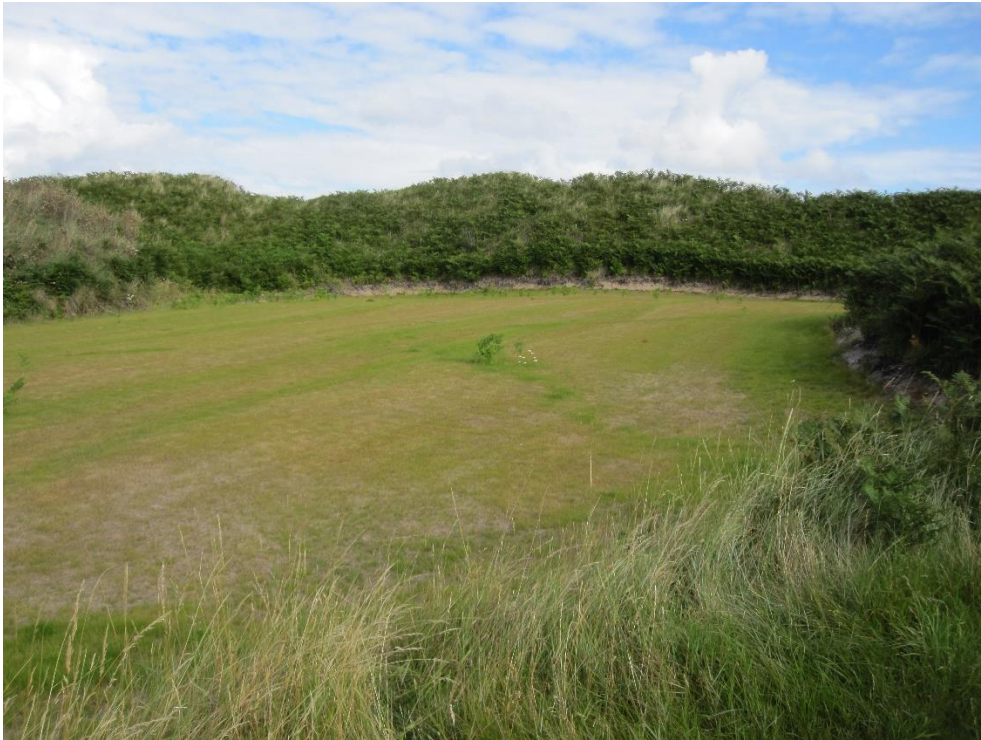
5 – Potential site of new storage tank and pump house @ turf nursery beside 4th Holes

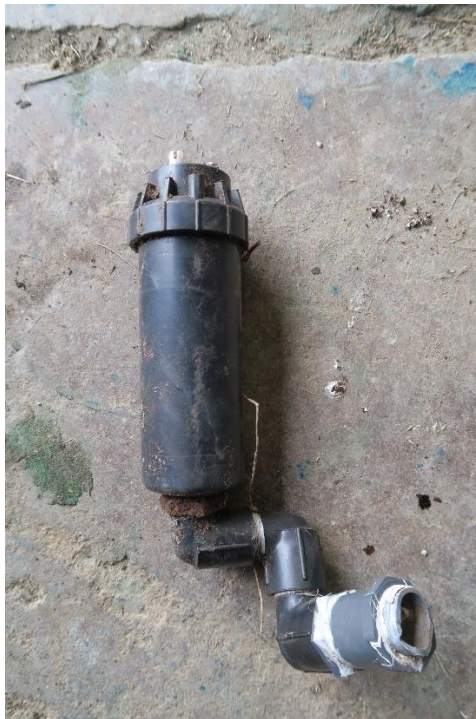
6 – Existing sprinkler connections

– Note; failing galvanised steel and poor articulation for adjusting sprinkler heights

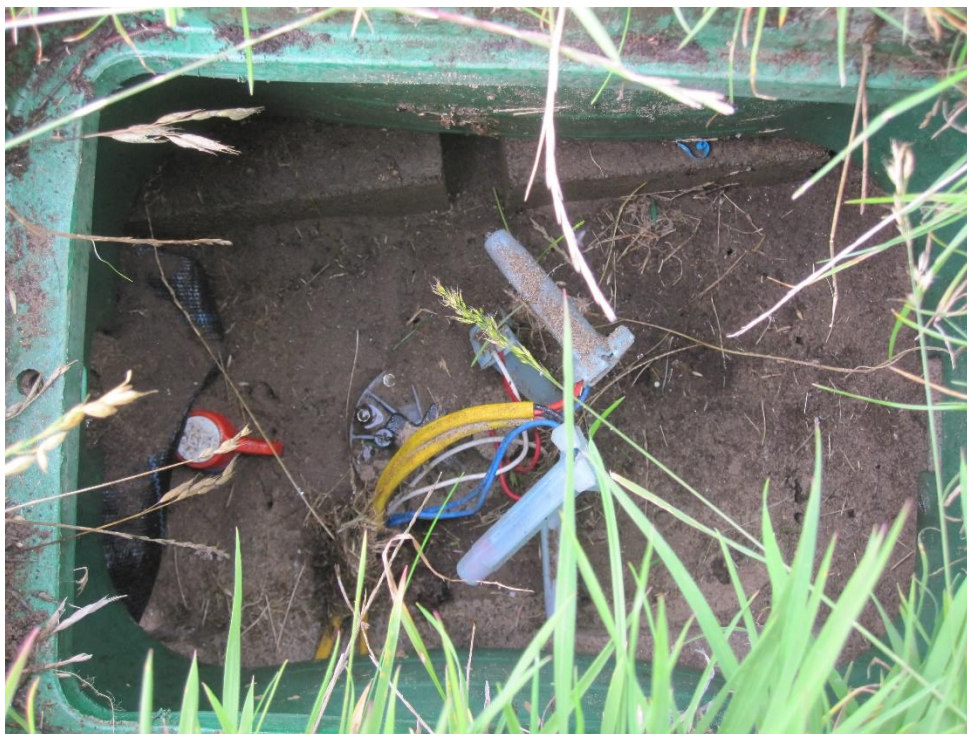
7 – Typical solenoid valve – Note; valve condition and no pressure regulation

2.48 The solenoid valves for the greens irrigation are showing the signs of 25+ years and will need replacement.

2.54 The solenoid valves use Richdel models, like the greens, which are not fitted with pressure regulation (it cannot be fitted). This means that during operation the sprinklers are subject to full system pressure minus any friction and elevation losses. With the nature of the golf course there will be some sprinklers which are operating at 8+bar when they are likely rated for less (this is the same for the greens). This will damage the sprinklers and affect their operation etc.

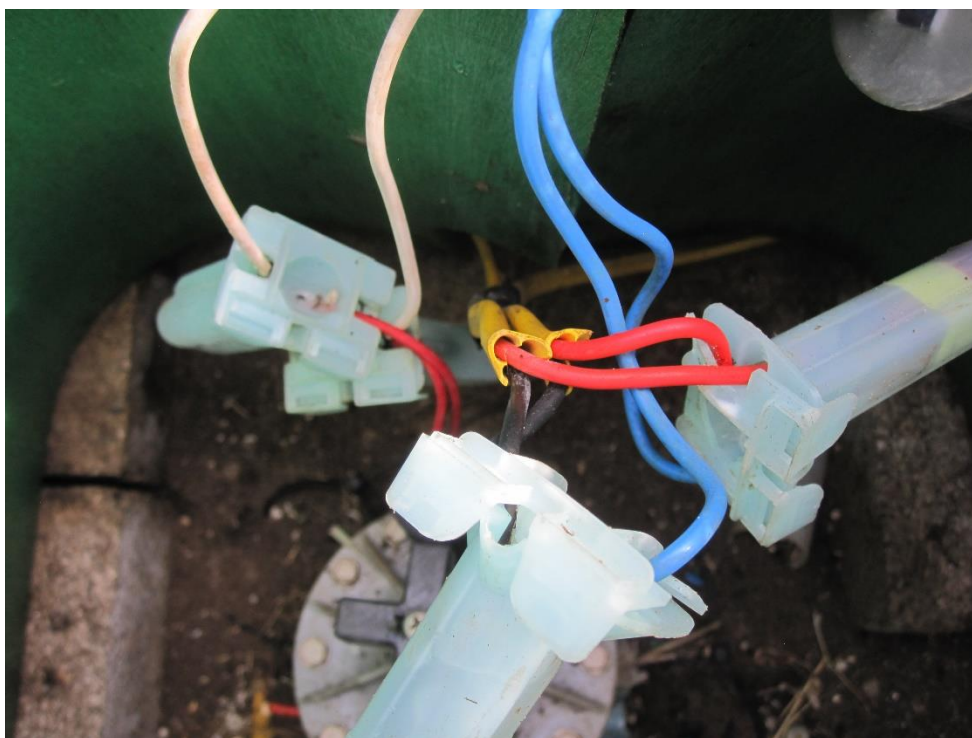
8 – Existing control cable

- 2.38** The control cable network uses a two-core cable which is 30+ years old. The Greenstaff do experience some problems with the control cables. The Rainbird decoders are known to be very reliable.

- 2.39** The existing control cable is unlikely to be suitable for re-use with the modern generation of irrigation computer control systems, however, manufacturers do have computerised controllers, often with many of the same features which could possibly be used with the existing control cables although this would need verification from the irrigation manufacturer. As the main line pipe work must be upgraded, however, then then new control cables would be installed with the new pipe work.

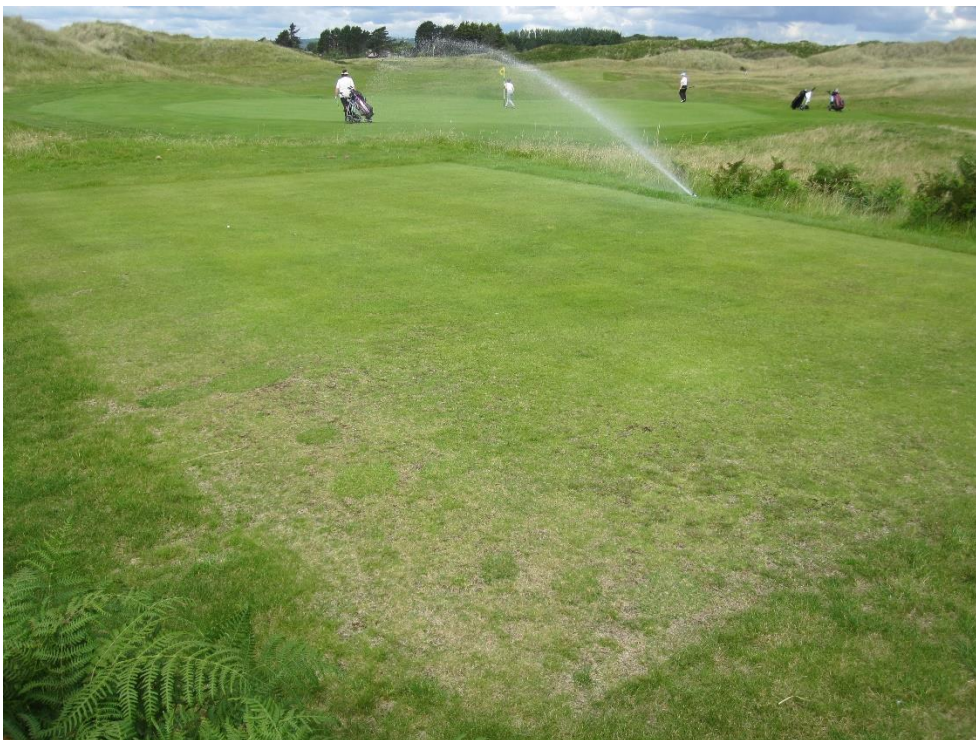
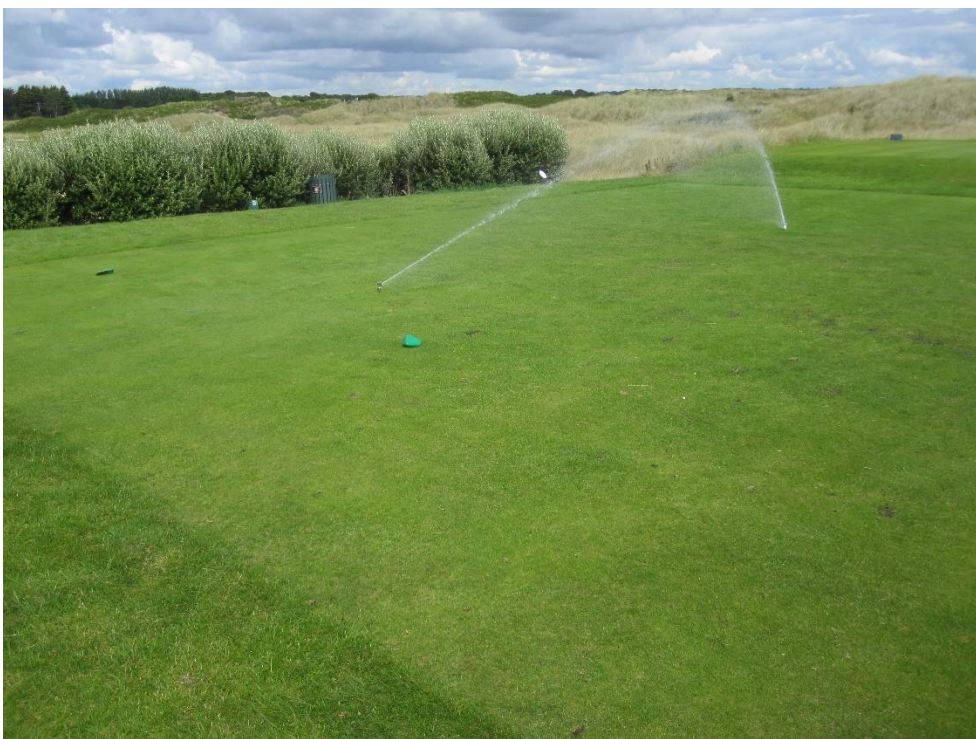
9 – Typical tee irrigation – Note; poor coverage [dry areas at corner]

2.53 All tees within a teeing complex are also operated off one solenoid valve and therefore it is impossible to schedule irrigation efficiently thus wasting water. This is compounded by the fact that the sprinkler spacings are very poor (wasting much water) and vary from tee to tee on the same solenoid valve. It is therefore completely impossible to control moisture levels consistently on the teeing surfaces.

- *The golf club should plan for replacement of the tees irrigation.*

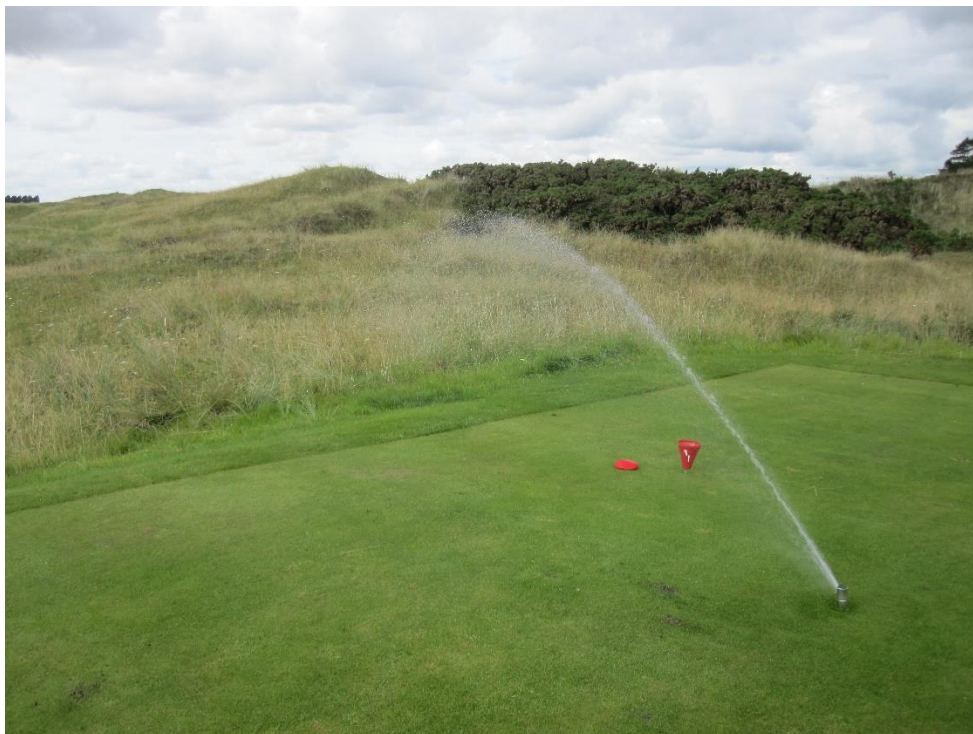
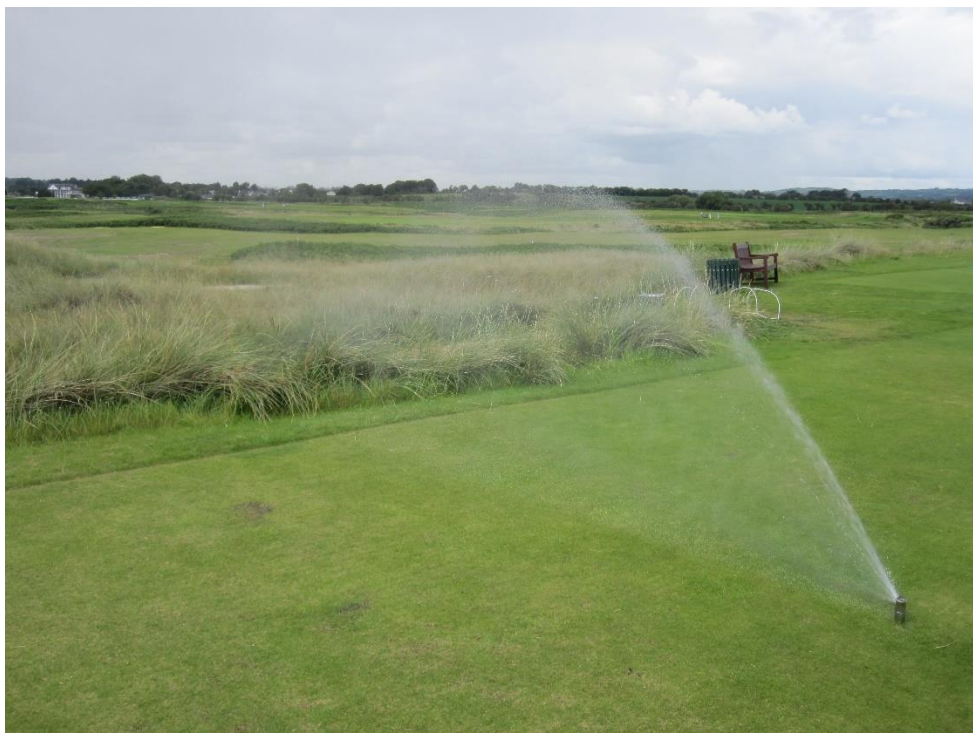
10 – Typical tee irrigation

– Note; single sprinkler in middle wasting 40% of water off the teeing surface

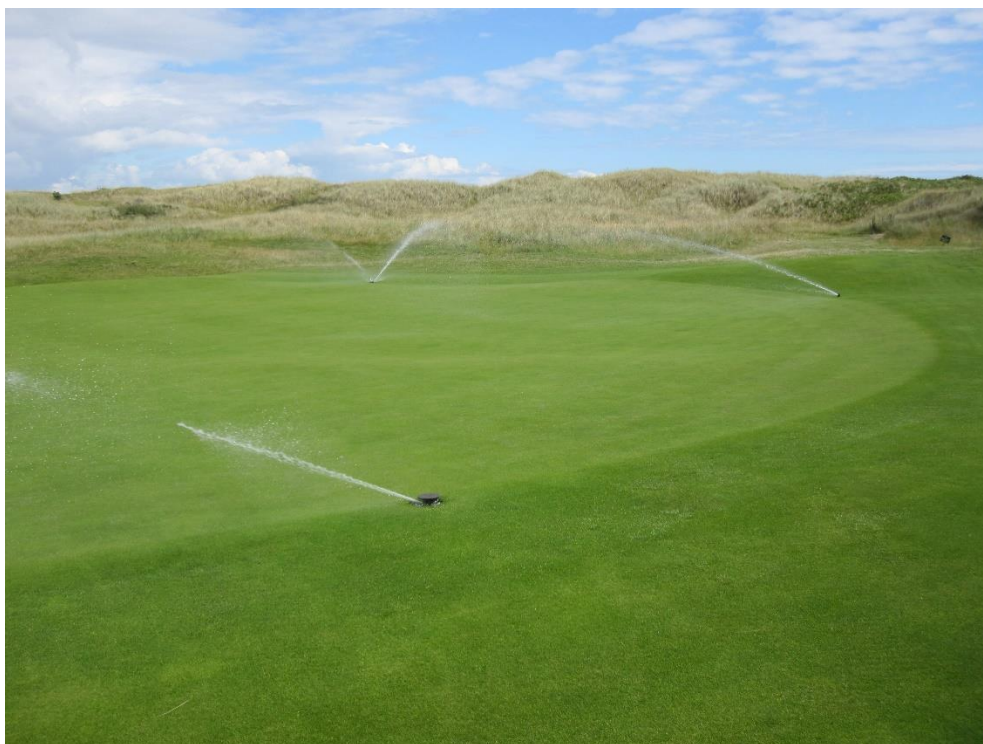
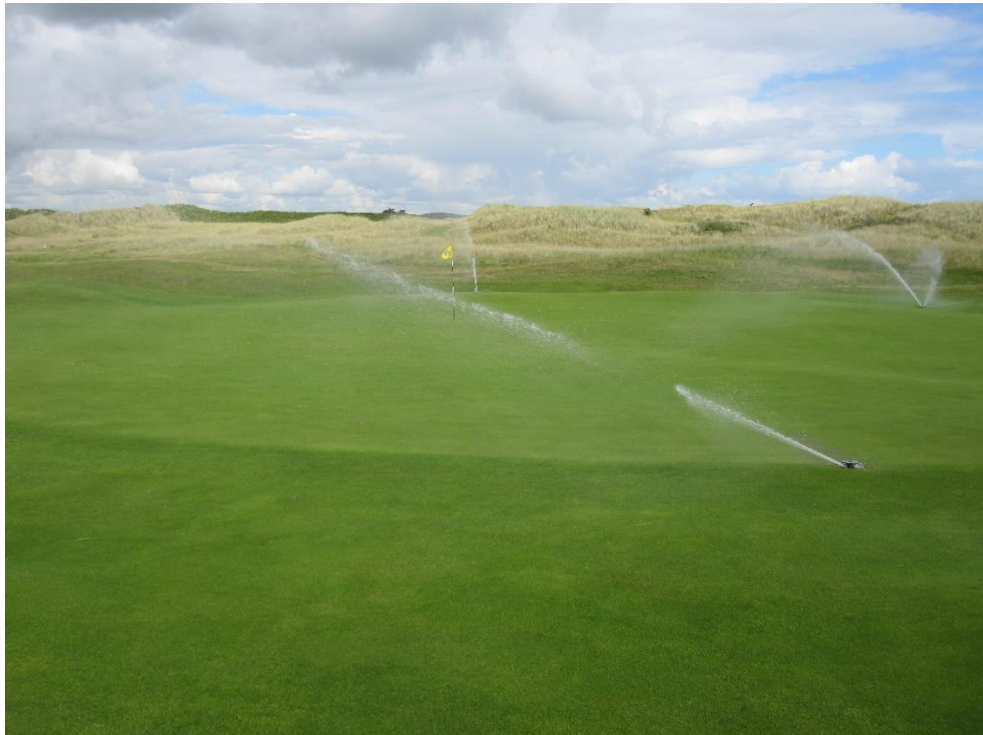
11 – Typical green irrigation – poor pressure and coverage

- 2.46** During the visit the operating pressures at individual greens sprinklers were taken using a pitot gauge [these were not taken when an automatic cycle was operated from the irrigation computer controller so unfortunately are not a true reflection of night time pressures]. The sprinklers were operating anywhere between 5.0bar and 6.5bar depending upon where the green was located on the golf course.

- *The golf club should plan for replacement of the green irrigation using modern valve-in-head control and back to back sprinklers to allow for independent control of the putting green over the green surround thus allowing water to be targeted to where it is needed and not wasting water.*

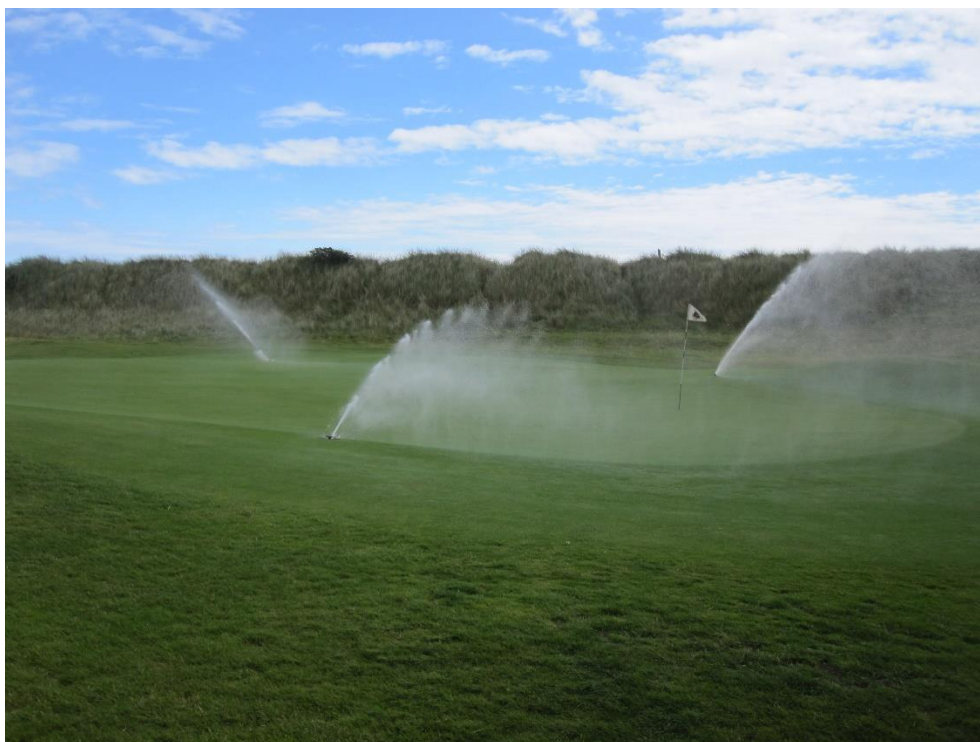
12 – Typical green irrigation – improved pressure, coverage still poor

- 2.45** The sprinkler spacing’s were checked on greens 2nd / 4th / 13th / 17th. These were found to be variable on most of the greens ranging from 14m to 24m between the sprinklers. Where sprinkler spacing is poor this will affect the water distribution onto the green and therefore how uniformly the greens are watered. The only way to offset this is to use variable nozzles in the green sprinklers which is never ideal and not the norm. This would also be more difficult with block control.

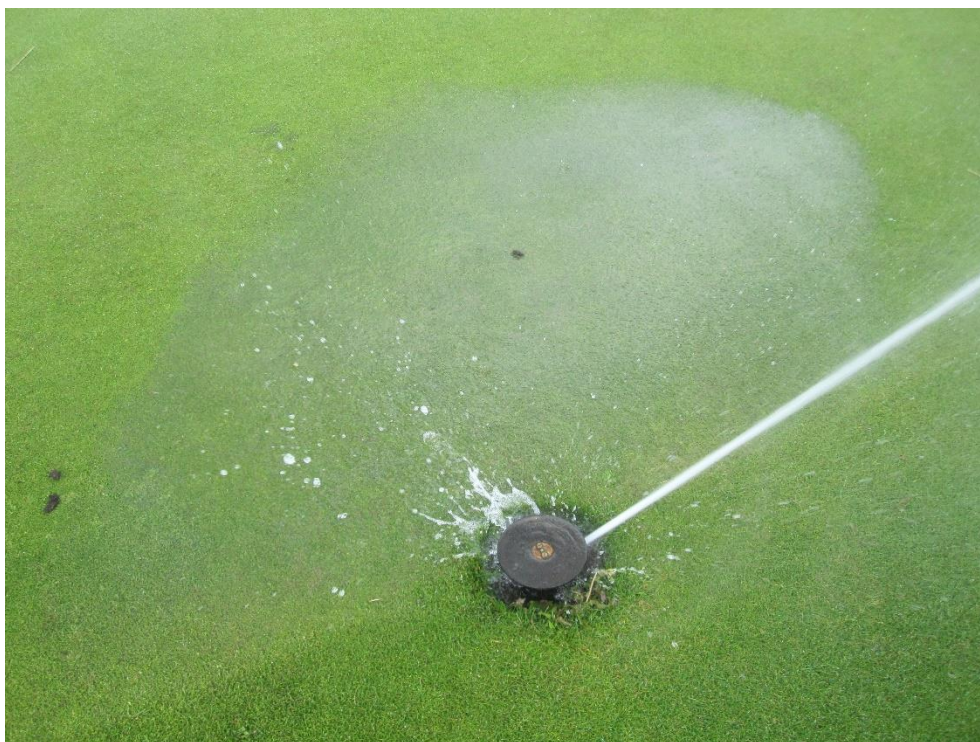
13 – Typical green sprinkler leaking around sprinkler head during operation

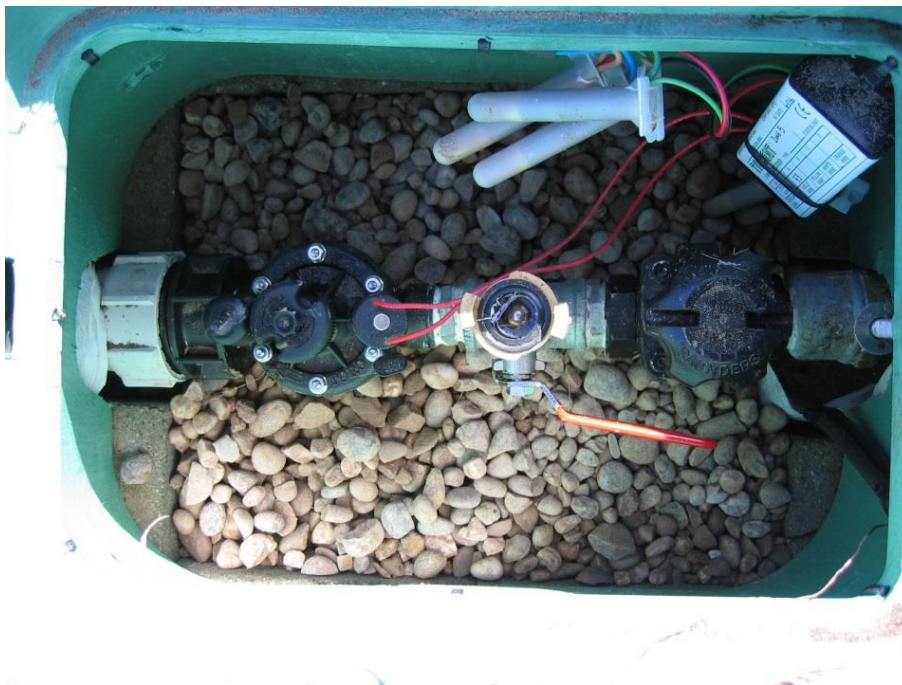
14 – Modern Tees Solenoid Valve [example photograph]
- note good access to all components etc.

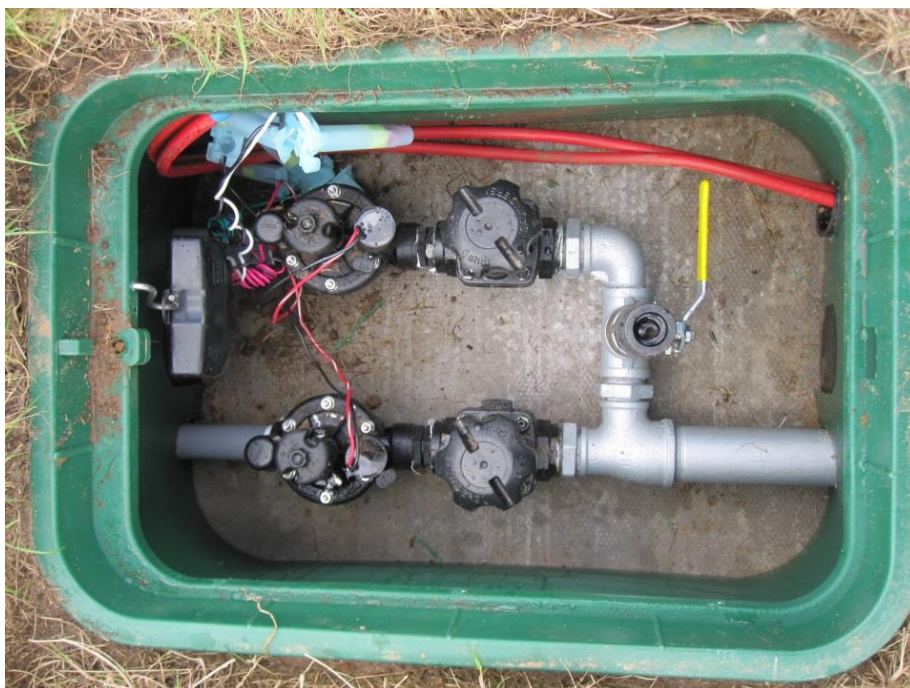
15 – Correct Cable Terminations in water tight DBY/R-6 connectors [example photograph]

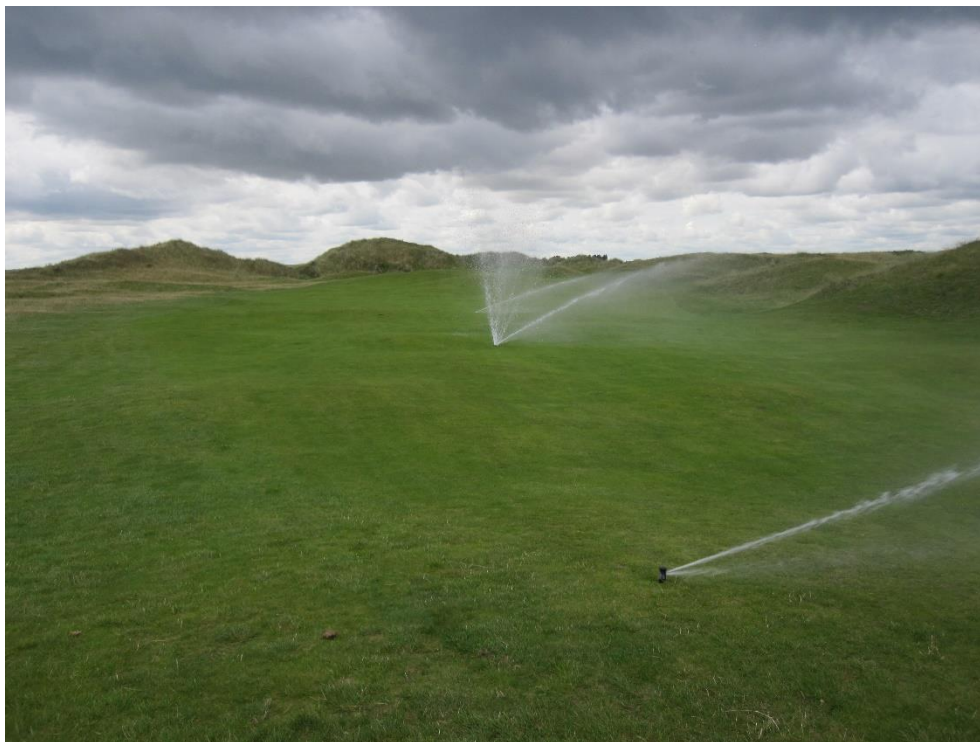
16 – Typical fairway irrigation – Note; single row and wind disturbance

- 2.60** The fairway sprinklers are configured in an ‘in-line’ configuration. Therefore the sprinklers are prone to wind disturbance and do not apply water to the fairways evenly with areas not receiving water. In-line configurations are wasteful of water, extremely inefficient and are not really suitable for links courses.

- 2.61** The 18th fairway has a double row installed, however, it was reported not to be fully operational.
- 2.62** *Recommendations;*
- *The golf club should plan for replacement of the fairway irrigation.*

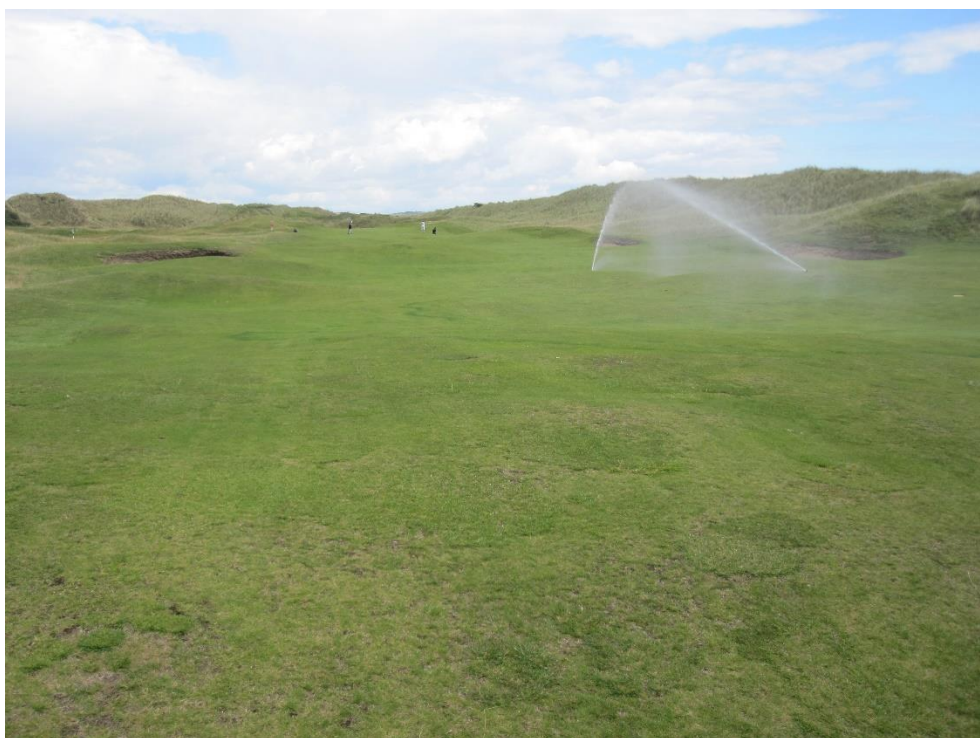
17 – Typical fairway irrigation – Note; poor coverage shown by turf quality

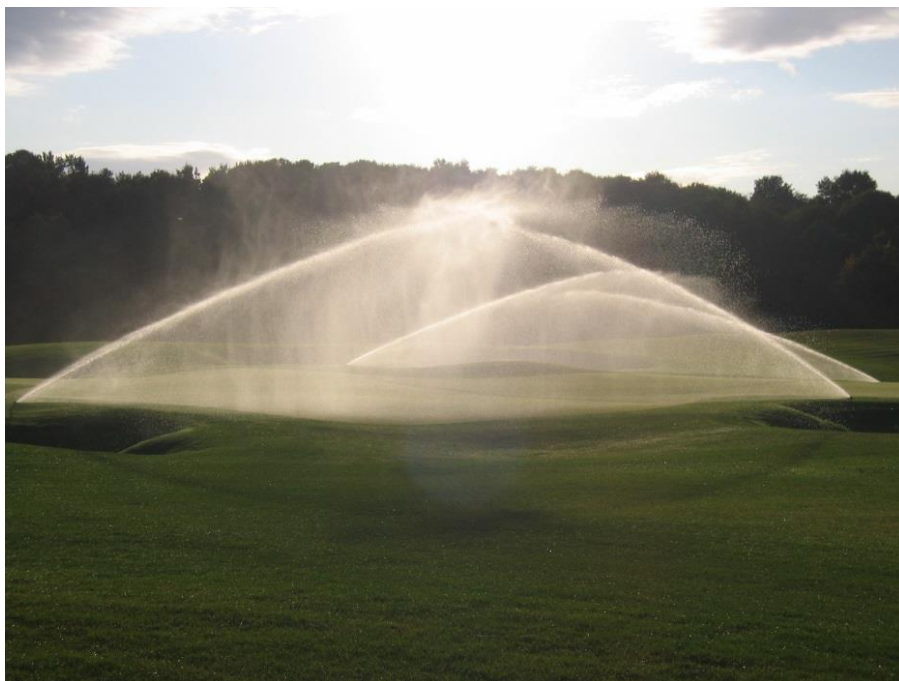
18 – Modern Valve-In Head Sprinklers in Operation [example photograph]
– note good curtain of water and coverage [low angle nozzle shown for windy conditions]
